GUILFORD LAKE DAM

ST. LOUIS COUNTY, MISSOURI

MO 31137

PHASE 1 INSPECTION REPORT NATIONAL DAM SAFETY PROGRAM

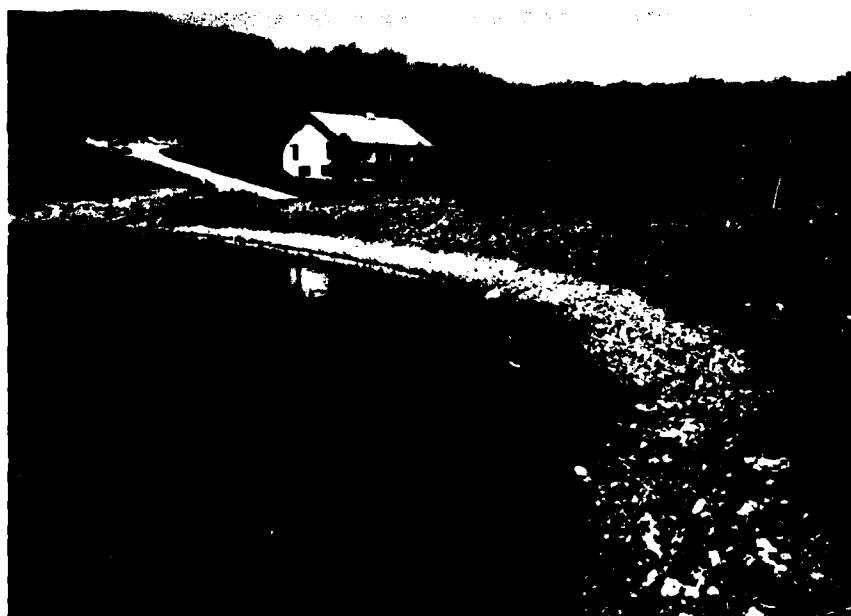
PHOTO 2: UPSTREAM FACE OF DAM LOOKING NORTH

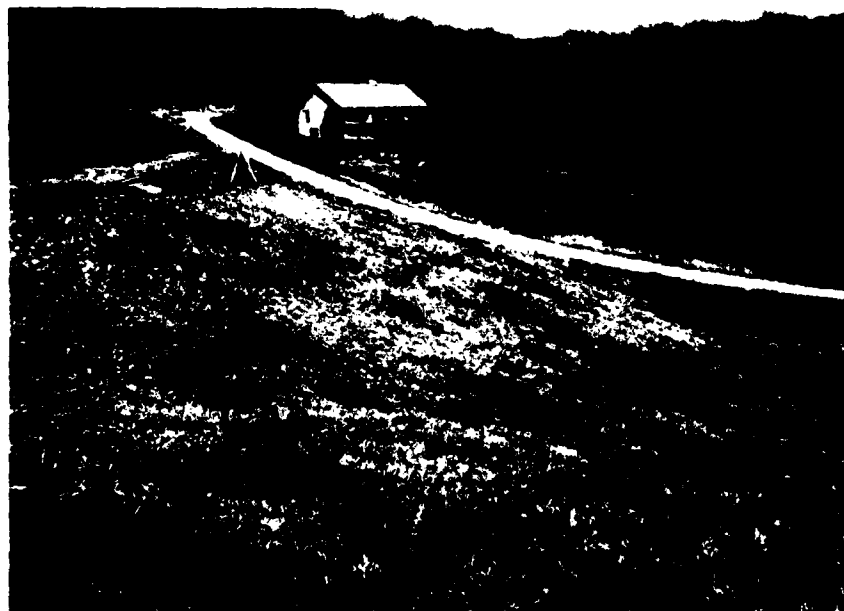
PHOTO 6: DOWNSTREAM FACE OF DAM LOOKING NORTH
